✓ A VISUAL ASSESSMENT OF REHABILITATED SURFACE
COAL MINES IN THE WESTERN UNITED STATES/

A MASTER'S THESIS

MASTER OF LANDSCAPE ARCHITECTURE

KANSAS STATE UNIVERSITY
Manhattan, Kansas

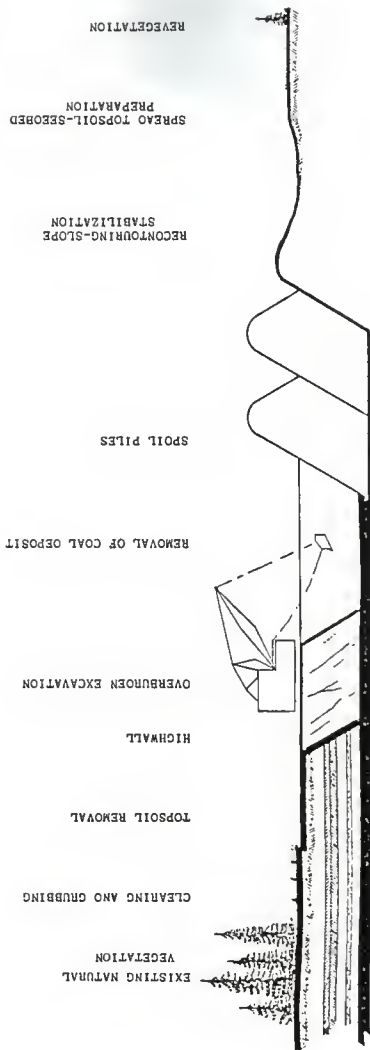
FIGURE 2.02: Area Strip Method of Mining (Source: Mined-Land Rehabilitation, Law, 1984).

In the coal bearing regions of the West the terrain is flat or gently rolling and extensive coal deposits (as much as 150 feet thick) lie relatively close to the earth's surface (usually within 150 feet). The most commonly used method to extract coal is the area strip mining method (Figure 2.02). To extract the coal a rectangular trench (boxcut) is made through the overburden to expose the layer of coal (seam). A huge dragline or shovel (some with bucket capacities of 220 cubic yards) makes successive parallel cuts and piles (spoils) the overburden in the previously cut trench. Haul trucks with capacities up to 175 cubic yards transport the coal for processing, storage, or transportation. When the mining process is complete, a succession of furrows and an open trench with exposed high wall remain (Law, 1984; Leopold, Rowland, Stadler, 1979).

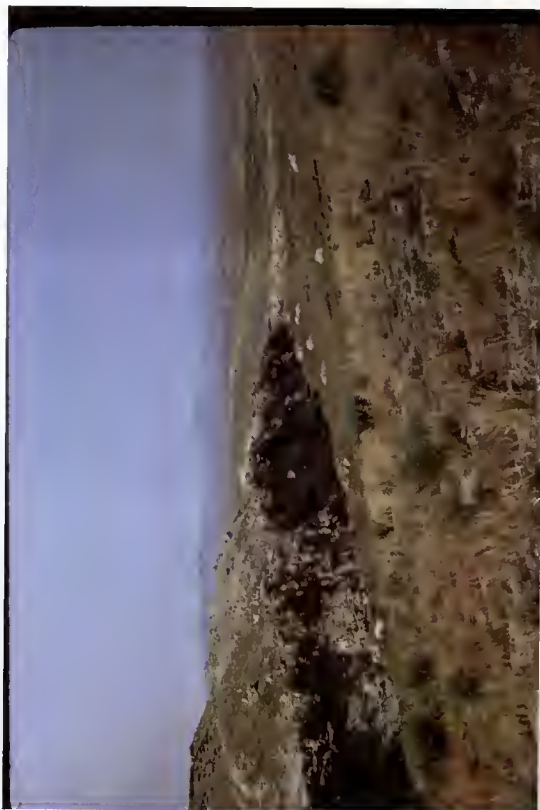
FIGURE 3.08: Study Site Three, Highwall Remnant

Rehabilitated land at the site fills gaps between hogbacks and rough break ridges. The edge where maturing vegetation meets the undisturbed ridge line becomes diffuse over time. The natural thickening of vegetation on north facing slopes emphasizes the folded land forms. The rehabilitated land, although flat or gently sloping, has a subtle overlapping or seesaw quality. Throughout the site boulders have been piled to replace the rocky habitats displaced by gently rolling grasslands. These rock deposits are large enough to provide cover for non-burrowing animals and high enough for roosting and nesting habitat. In one instance a highwall segment has been preserved which resembles premining landforms and provides additional wildlife habitat (Figure 3.08). Small sedimentation basins (some partially drained) also add topographical diversity. Mining operations and rehabilitation activities at this site have been

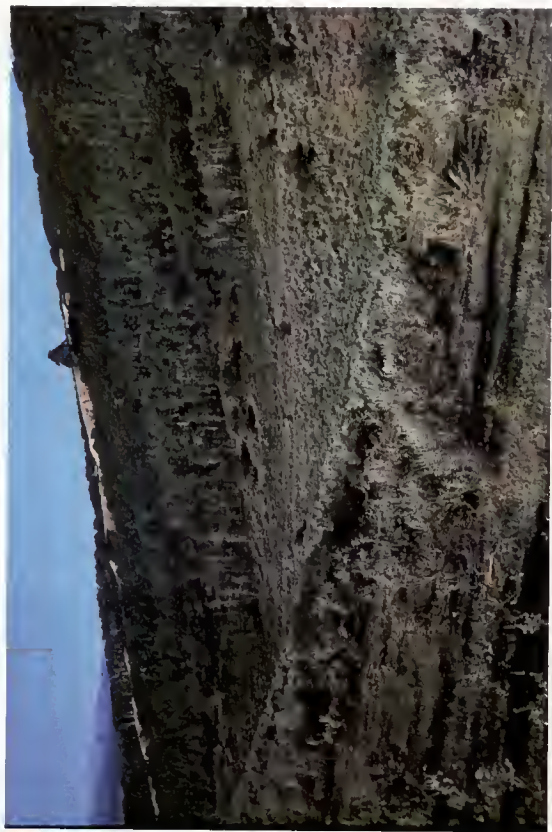
FIGURE 3.09: Study Site Four, Upland Sage/Aspen Ecotype
(photo by author, 1988).

by the diversity and differentiation in vegetation and landform (Figure 3.09). Although the visual qualities of each ecotype is distinct, they weave harmoniously through the landscape scene. Distant views of the parklands and river valley below further enhance the scene. The transmission towers so typical of the western landscape stomp across these lands as well. Their impact varies depending on vantage point and topography. With this exception, cultural modifications to the undisturbed landscape are limited.

Currently, the rehabilitated land within the permit area differs dramatically from the undisturbed lands nearby (including undisturbed lands that are left as "islands" within the rehabilitated parcels) (see Figures 3.09 and 3.10). While rehabilitated landforms are homogenized, the lack of mature overstory and shrub species is perhaps the most significant difference. In any case the contrast between the two landscapes makes a significant visual impact.

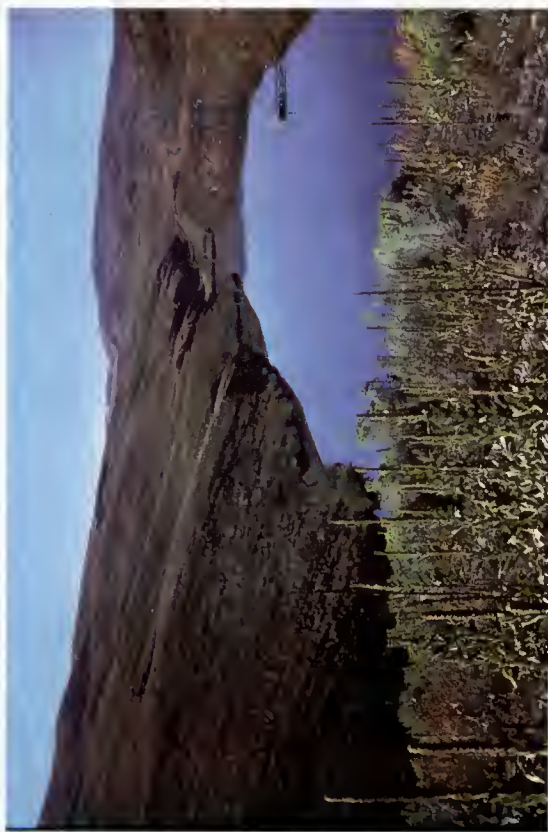
FIGURE 3.10: Study Site Four, Pre-SMCRA Rehabilitation and Pond (photo by author, 1988).

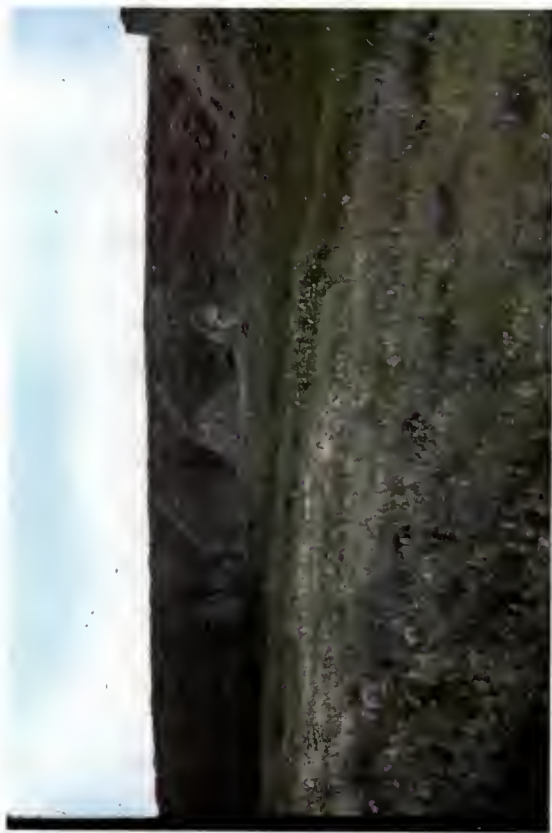
FIGURE 3.11: Study Site Five/Ephemeral/Intermittent Creek
(photo by author, 1988).

In terms of natural diversity, the creek drainages are undoubtedly the most significant landscape feature (Figure 3.11). Drainage ways meander across the plains, cutting dramatic sandstone scarp faces that can often be seen from miles away. Though flowing water seldom accompanies the channel, the brilliant green vegetation, in conjunction with the bleached scarps and dusty table lands is captivating.

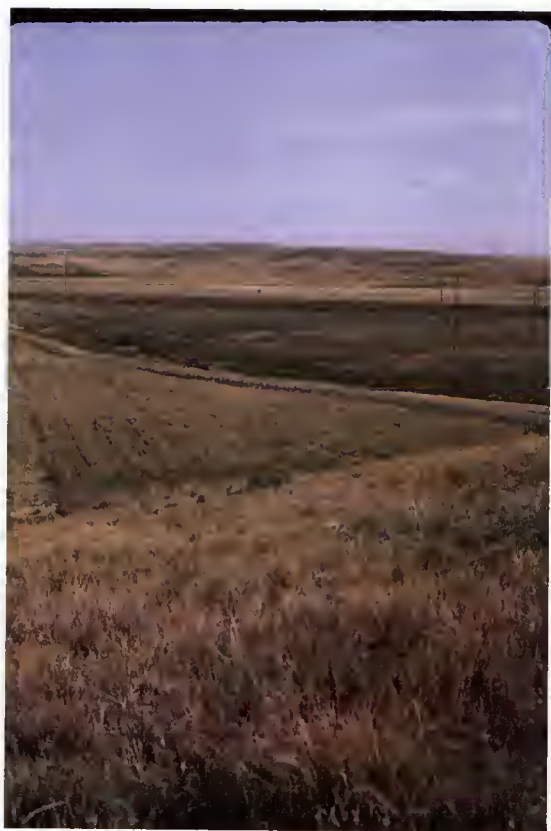
FIGURE 3.12: Study Site Five, Reconstructed Drainageway
(photo by author, 1988)

Abbreviated versions of the meandering stream beds have been created in the rehabilitated landscape (Figure 3.12). Although the Wyoming Department of Environmental Quality disallows steep scarp faces, the meandering, terraced character of natural drainages is subtly reconstructed. Rehabilitated tracts of varying maturity surround the creek bed. Topography varies; among the more pronounced is a steep sided hill that flattens into the creek bottom (Figure 3.12). Broad valley-like corridors also wind between the gentle ridges and hills. From now

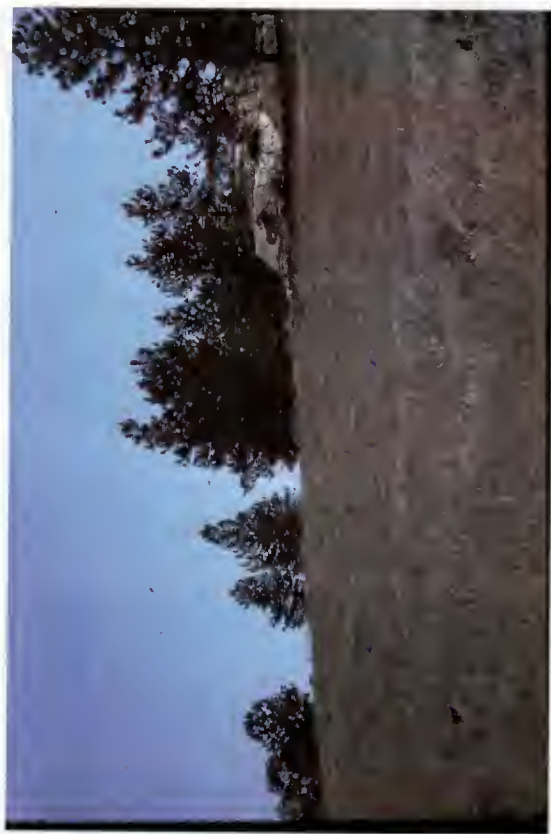
FIGURE 3.13: Ponderosa Seedlings
(photo by author, 1988).

Mining operations at this site progress up the valley bottom and flanking ridges. For the most part the rehabilitated lands evaluated are located on the slopes that rise to meet the ridge line. The lands all share a gentle, undulating quality. And in most cases, the evaluated lands are uniformly clothed in dense grasses. On the site's perimeter rehabilitated lands are meticulously matched to the existing terrain. Recently established ponderosa and sage seedlings mingle with the grasses -- almost shadowed by the mature stands close by (Figure 3.13). Grazing herds of buffalo, windmills, and retaining ponds filled with bass relieve the uniformity.

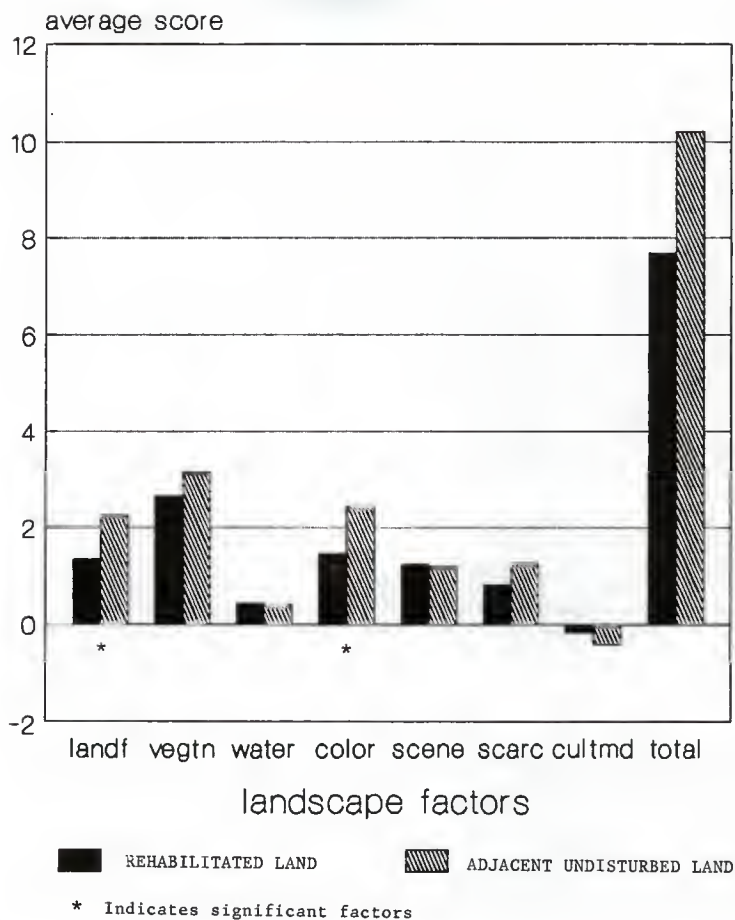
FIGURE 4.01: Visual Quality Rating Graph.

One of the objectives of this study is to identify how factors within the rehabilitated landscape influence visual quality. (See Research Intent Subsection, Chapter III.) With that goal in mind, scores for each of the seven landscape factors measured are compared in the manner described above (see Appendix B). For convenience the results are displayed graphically in Figure 4.01. Of the seven landscape factors measured, the greatest disparity between Rehabilitated and Adjacent Undisturbed Land is exhibited in the ratings for Landform (For $df = 33$, $p < .05$). Both mean scores and variability differ significantly (see Appendix B). These findings suggest that topographical diversity within and between the Rehabilitated Lands is significantly less than that

measured for Adjacent Undisturbed Land. With the exception of Color (see discussion below), none of the other landscape factor scores exhibit a statistically significant level (probability less than .05) of disparity. These results imply that the difference between the visual quality of Rehabilitated and Adjacent Undisturbed Land is primarily a function of Landform (i.e. topographical character, see Figures 3.01 and 3.02 for specific criteria). In light of this analysis the notion of a positive relationship between topographic variety and high visual quality is supported.
